UNBALANCED DOOR CONSTRUCTION REGARDING AUTOMATIC FLUSHBOLT PREPS

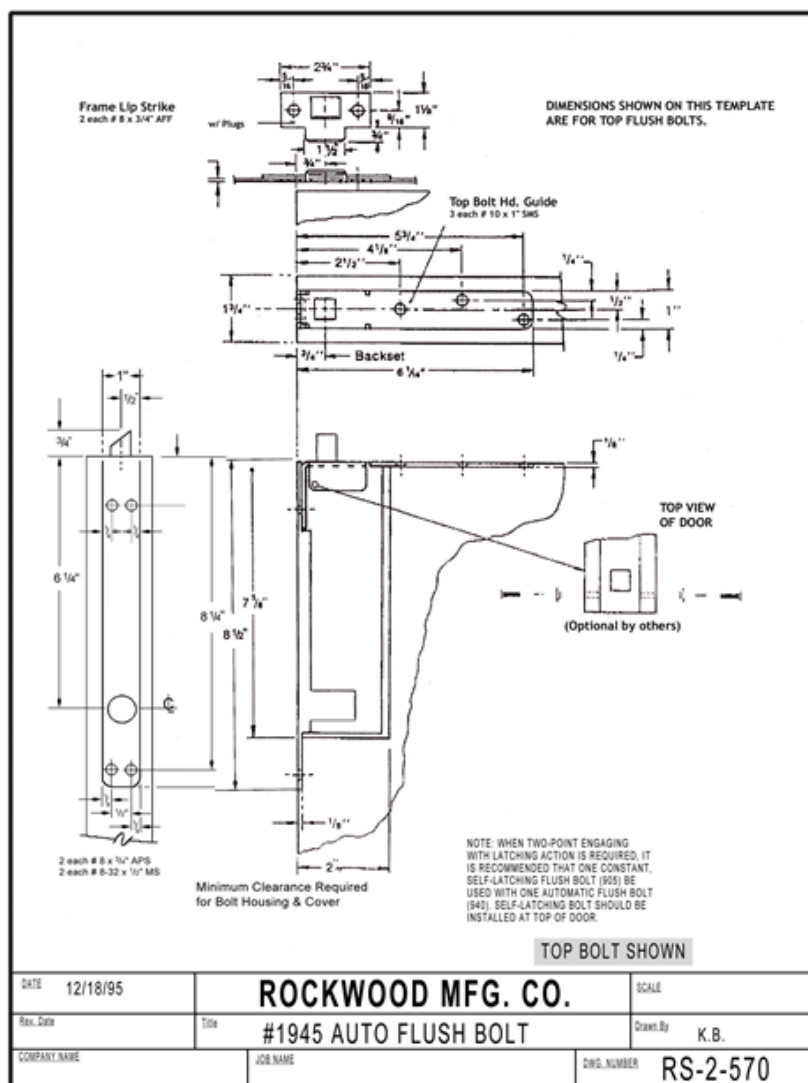
Automatic flush bolt preps in the inactive leaf of a pair of wood doors causes unbalanced construction (veneer/laminate on one face only) at the top and bottom corners of the meeting edge.

The unbalanced construction at these locations may cause the prep to warp, spread or open up. This is not considered a defect in workmanship or material, but rather a natural occurrence with unbalanced construction of a wood product.

1. Drill holes through the face of the door for set screws that will screw into holes on the side of the flush bolt and pull the prep back together (see auto flush bolt template at right).
2. Use a metal channel or astragal on the edge to keep the prep from warping.
3. Use a stainless steel clip (3/4" long by 1-3/4" wide with 1" legs) that can be slipped onto the top or ease of the door, secured in place with adhesive. This will be furnished by VT Industries if requested.

To avoid the possibility of warp or spread, the use of an extension flush bolt should be considered.
